Minerals Inspection Report

Mine Name: Talons Cove	Permit Number: M/49/0091	Mine Status: Active
Operator Name: TM Crushing	Inspection Date: 01/15/2015	Permit Fees: Paid
Inspector(s): A. Abate, W. Western	Inspection Time: 1:30 PM	Bond Amount: \$435,000
Attendee(s): Nick Baird, Jason Dansie	Weather: Clear 40s	Bond Escalation:
Inspection Purpose: Large Mine Permit Review Field Inspection		Prior Inspection: 03/06/2014

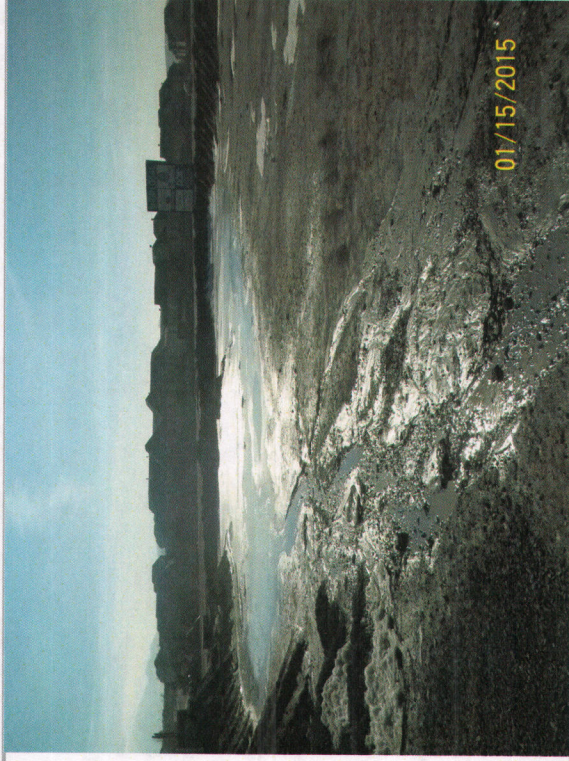
3. <i>Protection of Drainages/Erosion Control</i>	<input checked="" type="checkbox"/>	<input type="checkbox"/>
The sediment retention area at the entrance of the property was evaluated. Water was ponding up and back flowing toward the office trailers. Discussed with the operator blading a ditch and pitching the ground so that flow can be better directed toward the pond. Also discussed shoring up the berms around the pond. The operator agreed to provide photos after this work was completed.

Sediment Catchment Area near the entrance

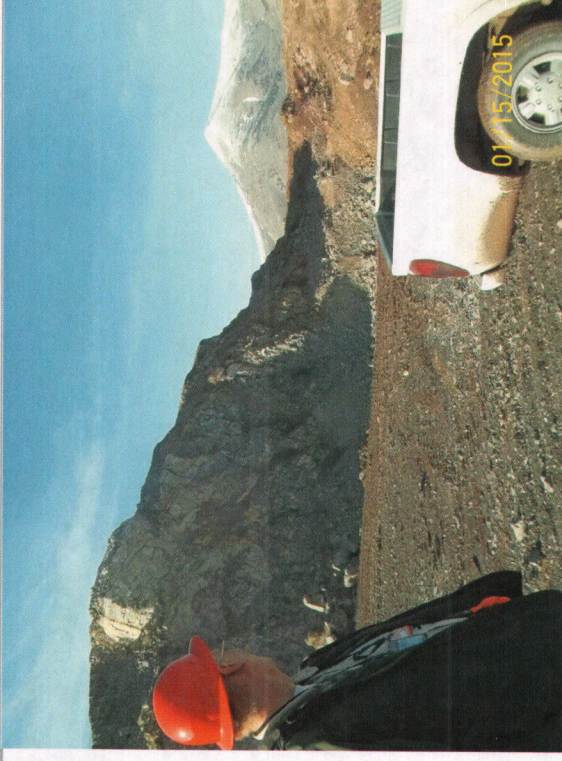
View from inside the existing pit. According to the operator, no highwalls will be left all areas will be mined out.

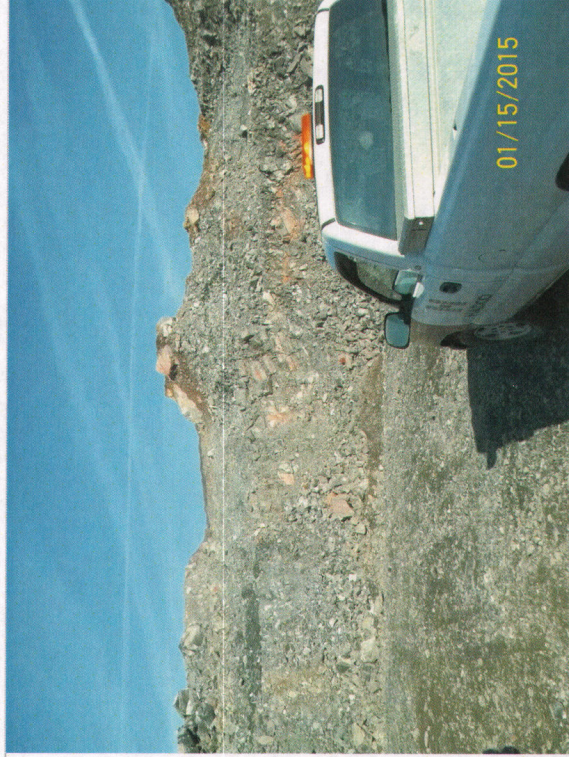
2. <i>Public Safety (shafts, adits, trash, signs, highwalls)</i>	<input checked="" type="checkbox"/>	<input type="checkbox"/>
Highwalls did not appear to be at an angle that would pose a public safety hazard. At reclamation highwalls are required to be left at an angle of 45 degrees or less by rule.

View of the highwall facing east.

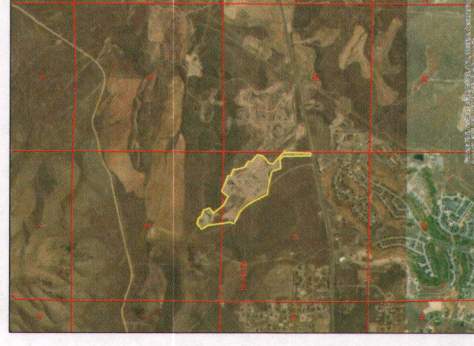
Approximate outline of current disturbance of Talons Cove.
